## "Full" Reserve Study

## **Williamsburg Settlement Katy , TX**

**Report #: 37636-0**  
**For Period Beginning: January 1, 2020**  
**Expires: December 31, 2020**

**Date Prepared: September 10, 2019**

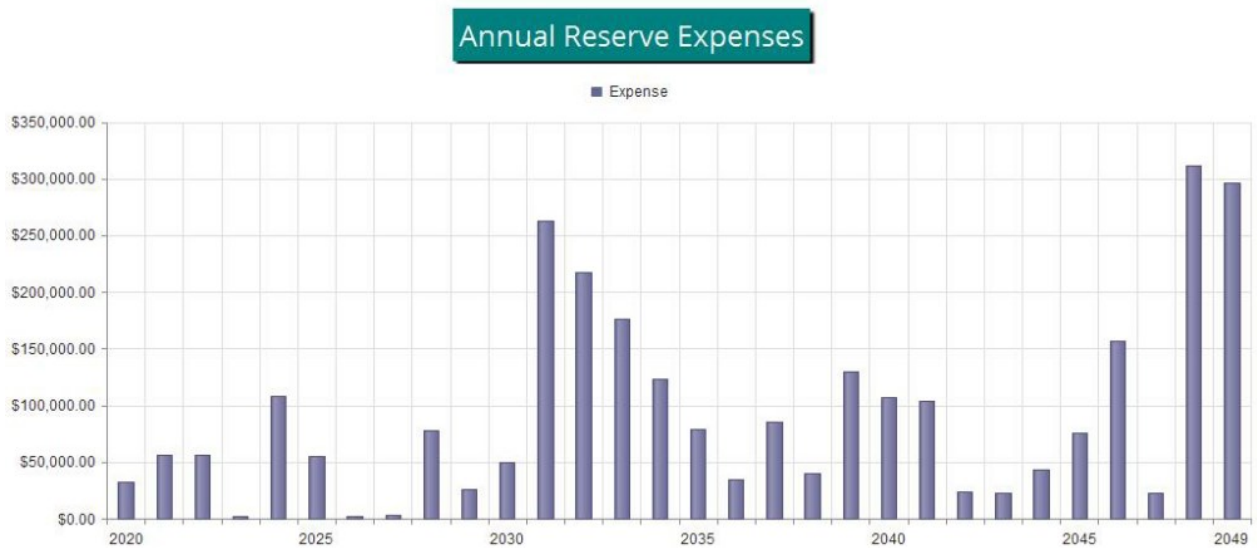
Figure 1

The figure below summarizes the projected future expenses at your association as defined by your Reserve Component List. A summary of these components are shown in the Component Details table, while a summary of the expenses themselves are shown in the 30-yr Expense Summary table.

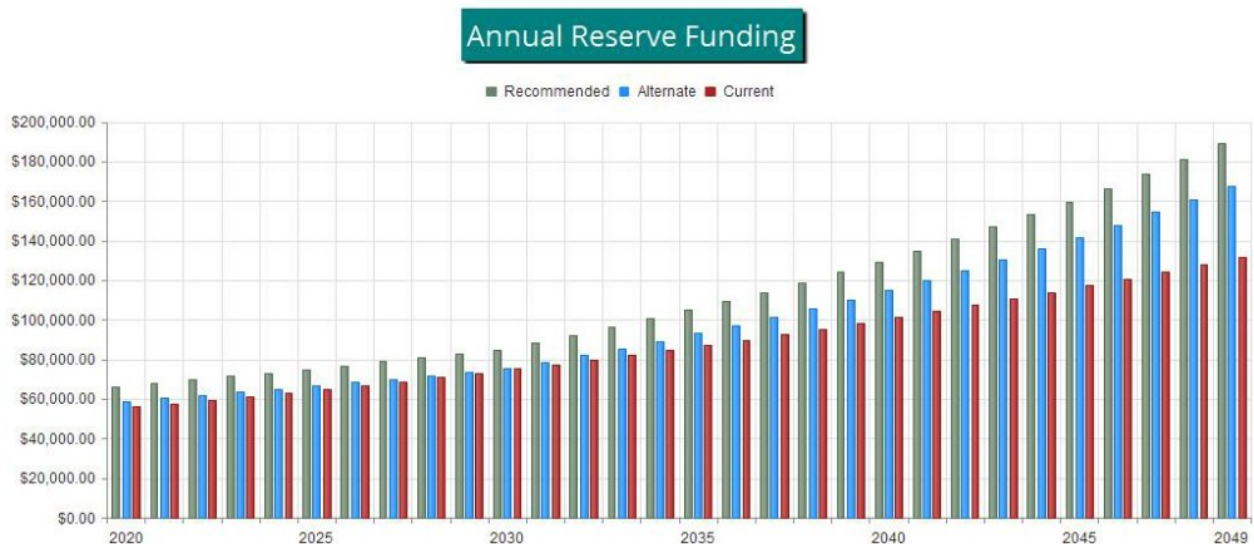
Figure 2

Based on your current Percent Funded and your near-term and long-term Reserve needs, we are recommending budgeted contributions of \$5,530 per month this Fiscal Year. The overall 30-yr plan, in perspective, is shown below. This same information is shown numerically in both the 30-yr Summary and the Cash Flow Detail tables.

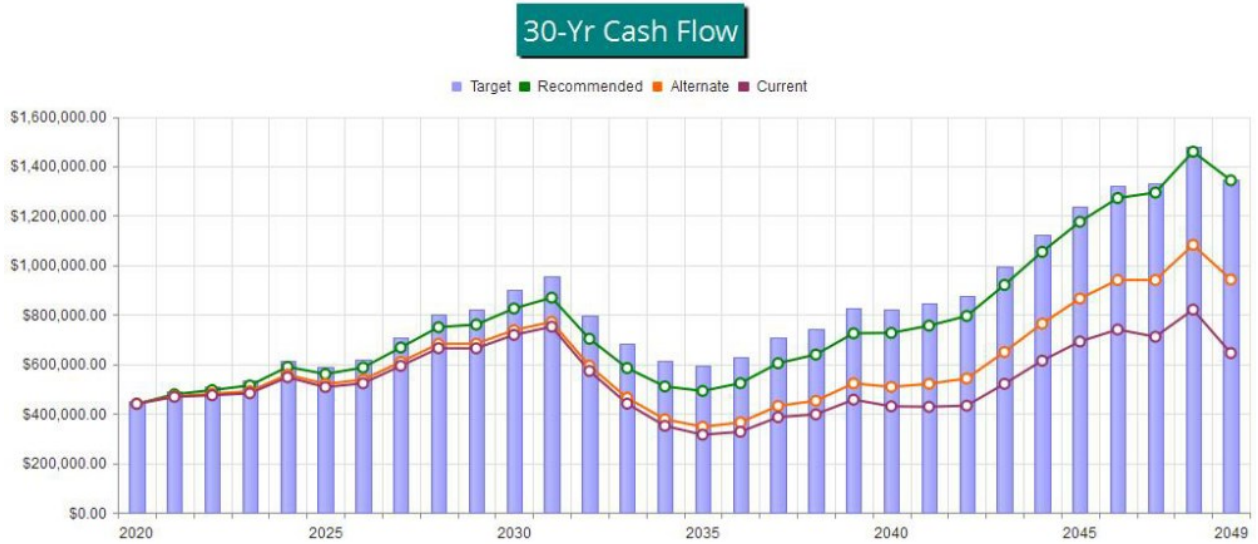
Figure 3

The following chart shows your Reserve balance under our recommended Full Funding Plan and at your current budgeted contribution rate, compared to your always-changing Fully Funded Balance target.

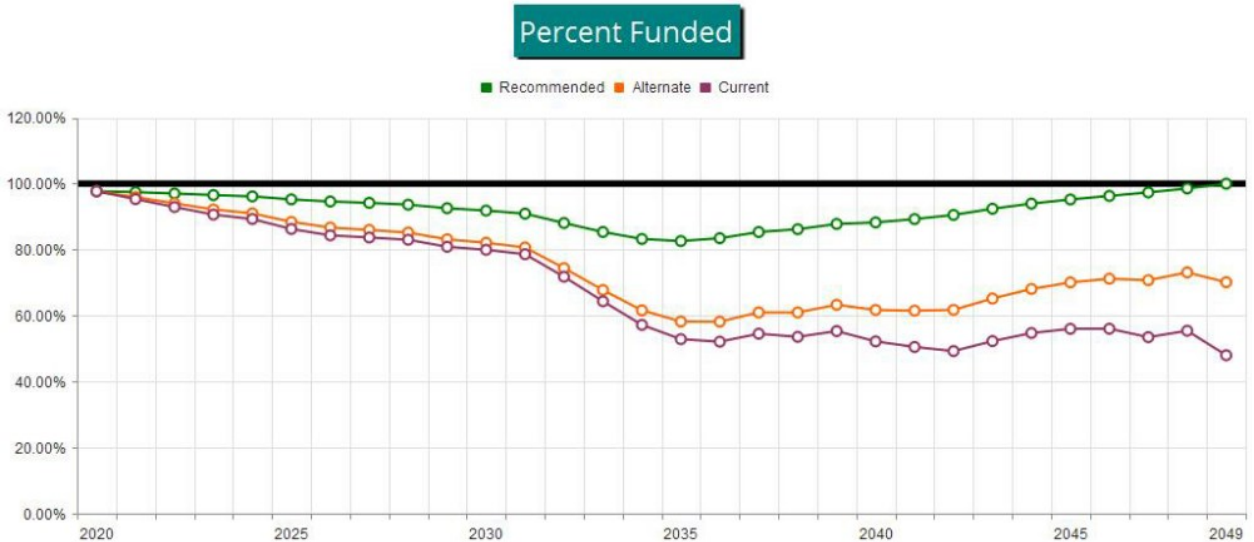
Figure 4

This figure shows the same information plotted on a Percent Funded scale. It is clear here to see how your Reserve Fund strength approaches the 100% Funded level under our recommended multi-yr Funding Plan.

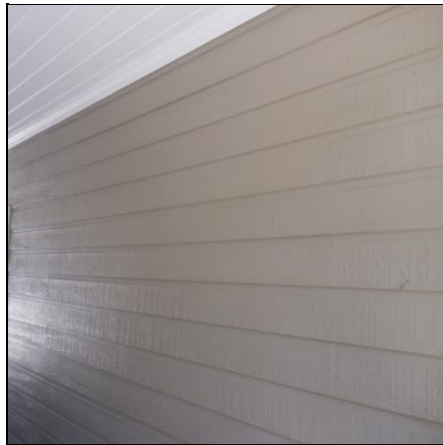
**Comp #: 1128 Fiber Cement Siding - Replace**

Comments: Fiber cement siding/trim sections determined to be in fair condition typically exhibit some color fading and inconsistency, with minor, isolated locations showing more advanced surface wear, cracking, splintering, etc. Association Reserves does not specifically endorse any products, manufacturers or vendors, but James Hardie Building Products, Inc. is the leading manufacturer of fiber cement siding, and their website ([www.jameshardie.com](http://www.jameshardie.com)) is an informative resource for proper care and maintenance of fiber cement siding. Their "Best Practices" guidelines offer specific guidelines for materials to be used; we strongly recommend complying with recommendations specific to your geographical area. We recommend that the Association consult with qualified exterior painting/waterproofing consultants and/or contractors to ensure that proper materials are used in painting and sealing the building siding.

Useful Life:  
40 years

Remaining Life:  
20 years

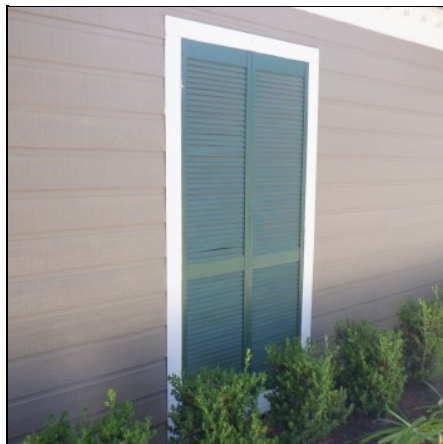
**Comp #: 1134 Wood Shutters - Replace**

Comments: The shutters were in fair condition at this time. No signs of damage or concern. Best to coordinate replacement with large exterior replacement projects. Funding included with #1128.

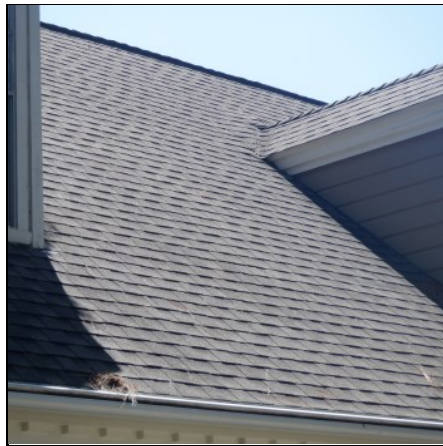
**Comp #: 1303 Asphalt Shingle Roof - Replace**

Comments: Asphalt shingle roofs determined to be in good condition typically exhibit few or no signs of curling/cupping of shingles, and granule cover appears to be thick and consistent. Little to no organic growth or staining patterns evident, and no unusual or significant leaks reported. Shingles and flashing appear to provide good coverage to all areas, especially at intersection points and around any penetrations. Dimensional shingles typically have longer useful lives and are generally considered to be more valuable from an aesthetic standpoint. We recommend budgeting to replace with dimensional shingles upon failure. Also known as architectural shingles, these types of roofs are typically more durable and wind-resistant than 3-tab shingles. Unless otherwise noted, costs shown here assume that only a minimal amount of substrate/decking repairs or replacement will be required. For very old roofs or those with significant leak problems, additional repair costs may be incurred. As routine maintenance, many manufacturers recommend inspections at least twice annually and after large storm events. Promptly replace any damaged/missing sections or conduct any other repair needed to ensure waterproof integrity of roof. Keep roof surface, gutters and downspouts clear and free of moss or debris. Moss growth can decrease the life of the roofing shingles and should be removed promptly. We recommend having roof inspected in greater detail (including conditions of sub-surface materials) by an independent roofing consultant prior to replacement. There is a wealth of information available through organizations such as the Roof Consultant Institute <http://www.rci-online.org/> and the National Roofing Contractors Association (NRCA) <http://www.nrca.net/>. If the roof has a warranty, be sure to review terms and conduct proper inspections/repairs as needed to keep warranty in force.

Useful Life:  
25 years

Remaining Life:  
16 years

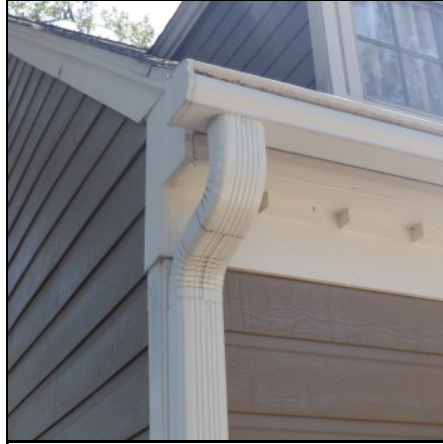
**Comp #: 1310 Gutters/Downspouts - Replace**

Comments: Includes: 124 LF of gutters and 40 LF of downspouts. Gutters and downspouts determined to be in good condition typically exhibit little to no significant surface wear or deterioration of material. No obvious sagging or tilting sections. Attachments to building appear to be strong and stable. Gutters and downspouts are assumed to be functioning properly unless otherwise noted. As routine maintenance, inspect regularly, keep gutters and downspouts free of debris. If buildings are located near trees, keep trees trimmed back to avoid accumulation of leaves on the roof surface which will accumulate in the gutters and increase maintenance requirements while reducing life expectancy. Repair or replace individual sections as needed as an Operating expense. We generally recommend that the gutters and downspouts be replaced when the roof is being resurfaced/replaced. National Roofing Contractor Association (NRCA) roofing standard includes installing eave flashings at the gutters. We suggest to plan for total replacement of gutter and downspouts at the same intervals as roof replacement for cost efficiency. Unless otherwise noted, costs shown here assume replacement with similar type as are currently in place.

Useful Life:  
25 years

Remaining Life:  
16 years

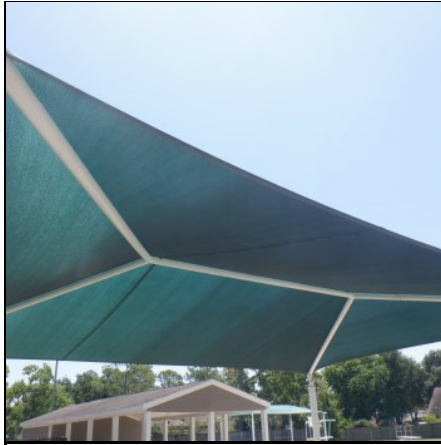
**Comp #: 402 Shade Awnings - Replace**

Comments: Shade or canopy structures determined to be in good condition typically exhibit few or no significant signs of wear or age. Color is bright and consistent, and all attachments and hardware are in good, serviceable condition. Canopy should be inspected, cleaned and repaired as needed on a regular basis to preserve good aesthetic condition. In many cases, framework/structure can be repaired and painted if needed to prolong useful life, sometimes indefinitely. Ensure that anchor points and hardware are in good condition, and take note of any recommendations for removal during high winds or storms.

Useful Life:  
10 years

Remaining Life:  
5 years

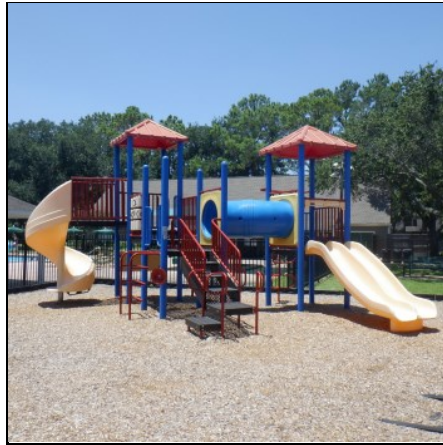
**Comp #: 405 Play Equipment - Replace**

Comments: Includes: (1) large play piece and (1) swing set. The pieces were in fair condition at this time. No damage or issues reported. Our inspection is not intended to identify any structural or latent defects, safety hazards, or other liability concerns. Funding recommendation shown here is strictly for budget purposes. As a routine maintenance expense, inspect for stability, damage and excessive wear and utilize maintenance funds for any repairs needed between replacement cycles. Life expectancy can vary depending on the amount of use/abuse. Unless otherwise noted, cost estimates assume replacement would be with comparable size and style of equipment as noted during inspection. Funding for replacement of the playground border is included in the cost below.

Useful Life:  
18 years

Remaining Life:  
8 years

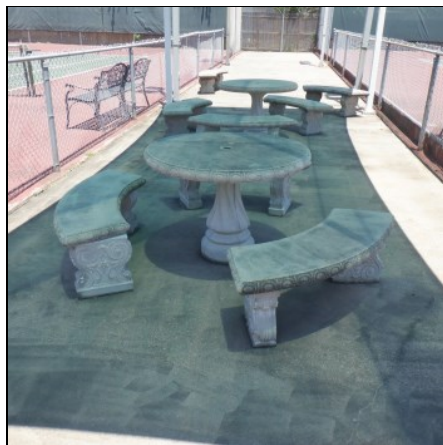
**Comp #: 406 Park Furniture - Replace**

Comments: Includes: (10) benches, (2) stone tables with benches, and (1) trashcan. Outdoor/site furniture determined to be in fair condition typically exhibits typical signs of wear and age. Style is still appropriate for the local aesthetic standards of the development. Inspect regularly, clean for appearance and repair as needed from general Operating funds. Cost to replace individual pieces may not meet threshold for Reserve funding. We recommend planning for regular intervals of complete replacement at the time frame indicated below, to maintain a good, consistent appearance in the common areas. Costs shown are based on replacement with comparable types unless otherwise noted.

Useful Life:  
15 years

Remaining Life:  
8 years

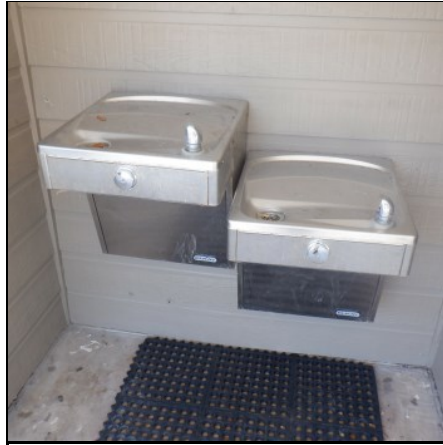
**Comp #: 411 Drinking Fountains - Replace**

Comments: The drinking fountains were in fair condition. No damage or corrosion noted. Expect a full useful life.

Useful Life:  
20 years

Remaining Life:  
5 years

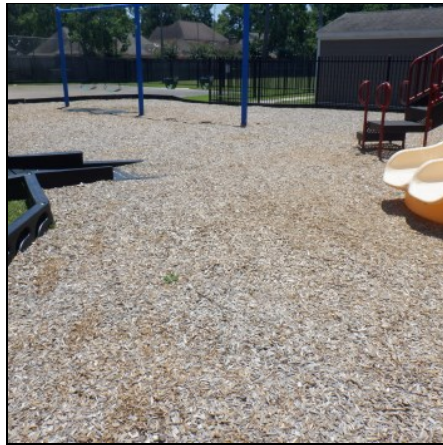
Comments: Playground surfaces should be inspected regularly for trip hazards, slip and fall risks, etc. Plan to replenish at the approximate interval shown here for aesthetic and functional reasons. When evaluating replacement options, the Association should consult with vendors to ensure adequate protection from falls. Costs shown are based on replacement with same surface type unless otherwise noted.

Useful Life:  
6 years

Remaining Life:  
3 years

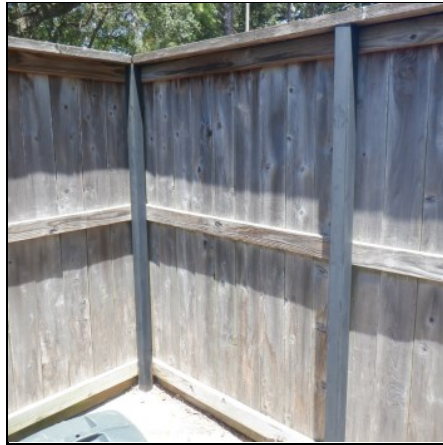
**Comp #: 505 Wood Fence - Replace**

Comments: Wood fencing determined to be in fair condition typically exhibits some minor to moderate amounts of surface wear and other signs of age, which may include a small percentage of warped, split and/or rotted sections. In general, appearance is consistent but declining. As routine maintenance, inspect regularly for any damage, repair as needed and avoid contact with ground and surrounding vegetation wherever possible. Regular cycles of uniform, professional sealing/painting will help to maintain appearance and maximize life. In our experience, wood fencing will typically eventually break down due to a combination of sun and weather exposure, which is sometimes exacerbated by other factors such as irrigation overspray, abuse and lack of preventive maintenance. Recommendation and costs shown here are based on replacement with similar style and material. However, the Association might want to consider replacing with more sturdy, lower-maintenance products like composite, vinyl, etc. Although installation costs are higher, total life cycle cost is lower due to less maintenance and longer design life expectancy.

Useful Life:  
20 years

Remaining Life:  
5 years

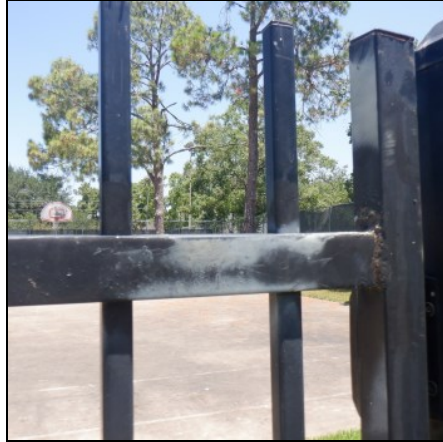
Comments: Metal fencing determined to be in fair condition typically exhibits a finish coat or surface which is mostly uniform but exhibits minor to moderate corrosion or rust. Coloring may be faded but is still mostly consistent. Metal fencing should be painted at the interval shown here in order to inhibit or delay onset of rust/corrosion and prevent or minimize costly repairs. Painting not only protects the metal surface from excessive wear, but promotes a good, attractive appearance in the common areas. Costs can vary greatly depending on existing conditions of fencing, which will dictate amount of repair/prep work required.

Useful Life:  
15 years

Remaining Life:  
2 years

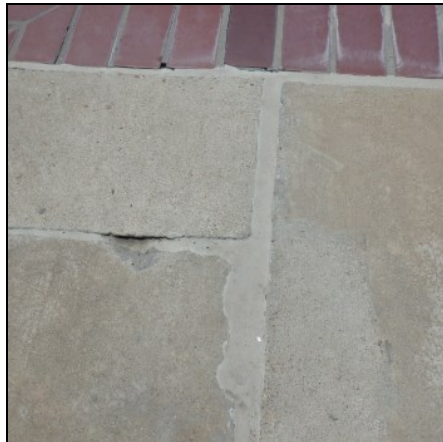
**Comp #: 1201 Pool Deck - Repair/Replace**

Comments: The decking surfaces were in overall fair condition. No significant cracking or damage observed. Pool decks may be exposed to harsh chemicals that can leave stains if not addressed properly. Periodic pressure-washing and re-coating will restore the appearance and prolong the need for major restoration or replacement of the deck surface. Take note of any places where water is ponding, which may result in slip-and-fall hazards if not corrected.

Useful Life:  
15 years

Remaining Life:  
9 years

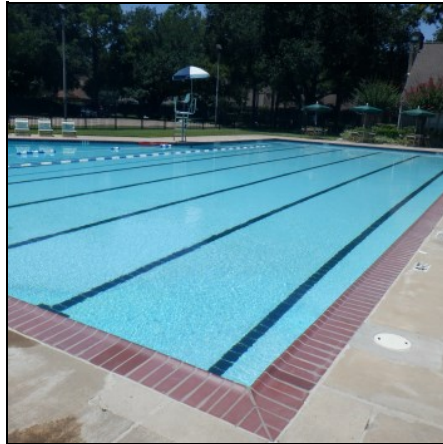
Comments: The pool surfaces were in fair condition at this time. No major deterioration or issues noted. Pool resurfacing will restore the aesthetic quality of the pool while protecting the actual concrete shell of the pool from deterioration. While drained for resurfacing, any other repairs to lighting, handrails, stairs, ladders, etc. should be conducted as needed. This type of project is best suited for slow/offseason to minimize downtime during periods when pool is used heavily. Should be expected at the approximate interval shown below; in some cases, schedule may need to be accelerated due to improper chemical balances or aesthetic preferences of the Association.

Useful Life:  
10 years

Remaining Life:  
1 years

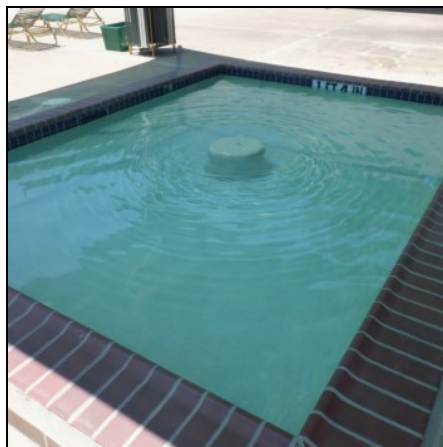
Comments: The surfaces were in good condition at this time. No areas of concern. Expect a full useful life.

Useful Life:  
10 years

Remaining Life:  
9 years

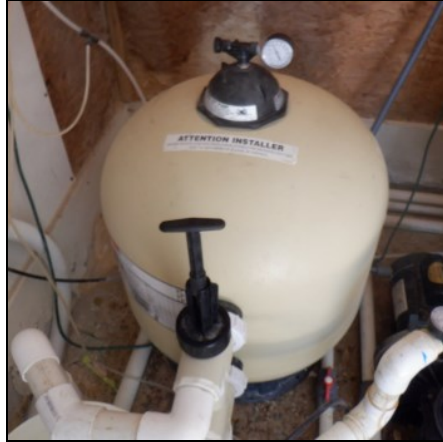
**Comp #: 1207 Pool Filter (2016) - Replace**

Comments: The filter was in good condition. No signs of active leakage. No reported issues. Pool vendor should inspect regularly for optimal performance and address any repairs or preventive maintenance as needed. Life can vary depending on location, as well as level of use and preventive maintenance. Plan to replace at the approximate interval shown below.

Useful Life:  
15 years

Remaining Life:  
11 years
